### US Dept of Interior (NPS) Hovenweep National Monument Square Tower Group: Tower 9

UNITED STATES  
DEPARTMENT OF THE INTERIOR  
NATIONAL PARK SERVICE  
HOVENWEEP NATIONAL MONUMENT

SQUARE TOWER CANYON GROUP  
TOWER 9 (FEWKES)

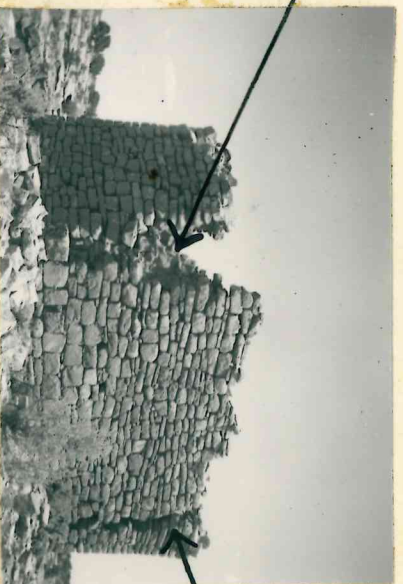
A.

This structure has suffered greatly. The original builders failed to bond or "tie in" corners and adjoining walls in the method of modern masonry. Consequently, natural elements have caused corners either to fall away entirely (IA), or to cleave apart and remain indefinitely in a most insecure position. (IIA, B)

Entire walls which have cleaved apart from adjacent walls and are leaning away from the vertical, will, it is believed, require considerable engineering to stabilize.

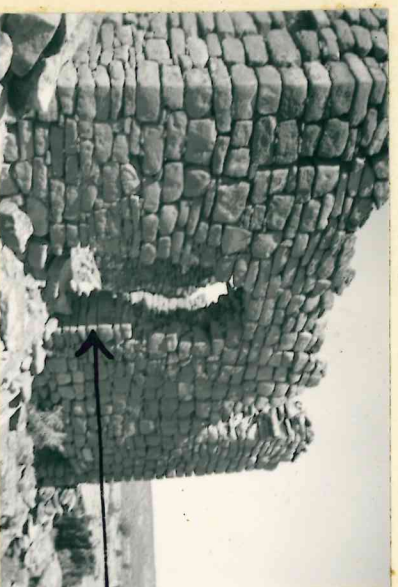
III

What was once a doorway (IIIC), is now an arched hole, and the 5 or 6 masonry courses above this arch are held together in an amazing fashion by means of the superb adobe of the prehistoric architects, with absolutely no support from beneath.
