HOVENWEEP NATIONAL MONUMENT

SQUARE TOWER CANYON GROUP

HOVENWEEP CASTLE

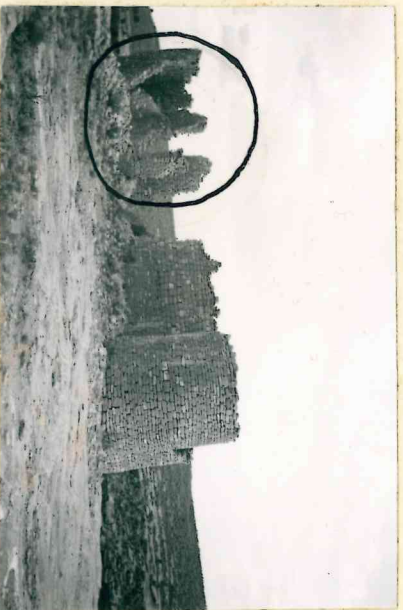
A.

Compare A with Fewkes' illustration, Bulletin #70, Bureau of American Ethnology, Plate 222, and it will be noted that large portions of the walls in the so-called eastern section (Fewkes) of the Castle (encircled) have collapsed in recent years. These should be restored to some extent, then capped, if they are to remain standing another

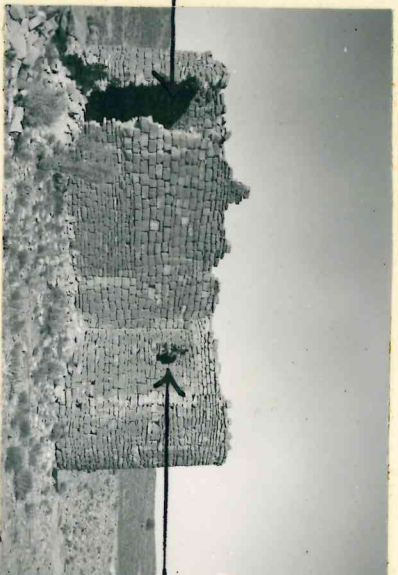
20 years. Band C are two views of the western section. I B, the end wall, has fallen away and should be restored. II B is an unnatural hole (i.e., has been caused either by weathering, or the work of the vandals) and should also be repaired, so as to conform with the original contour of this semi-circular tower section.
